# **Assembly Park**

Assembly Hall Committee

# Assembly Hall's Current Condition

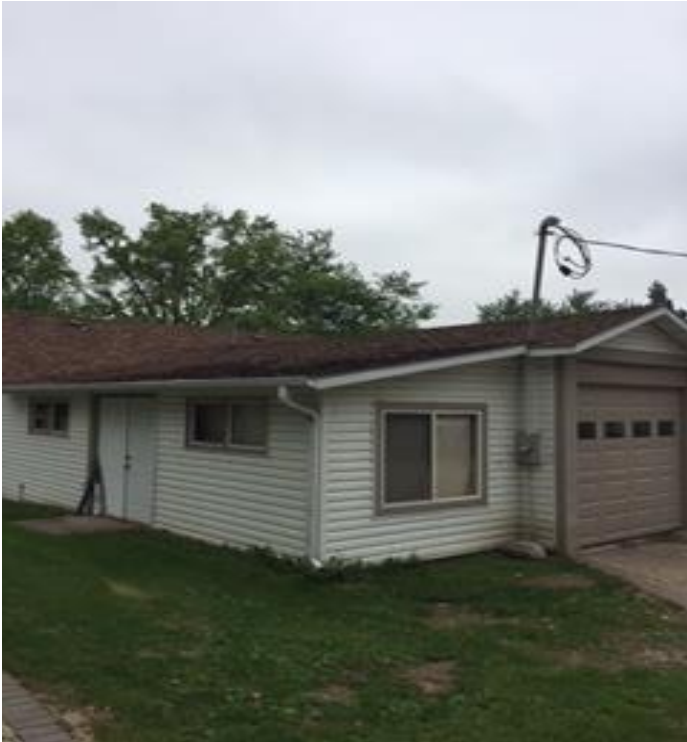
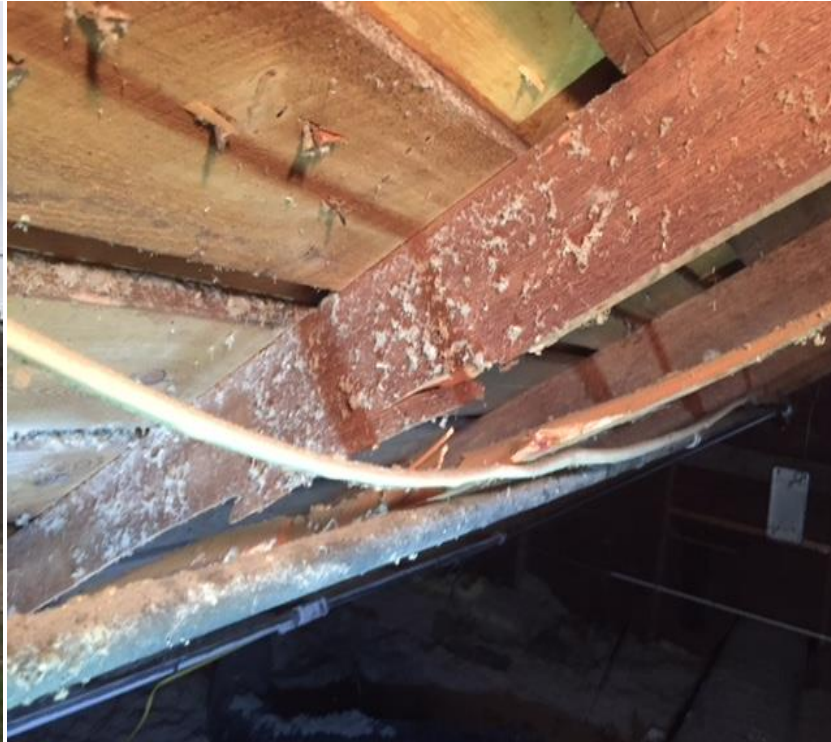
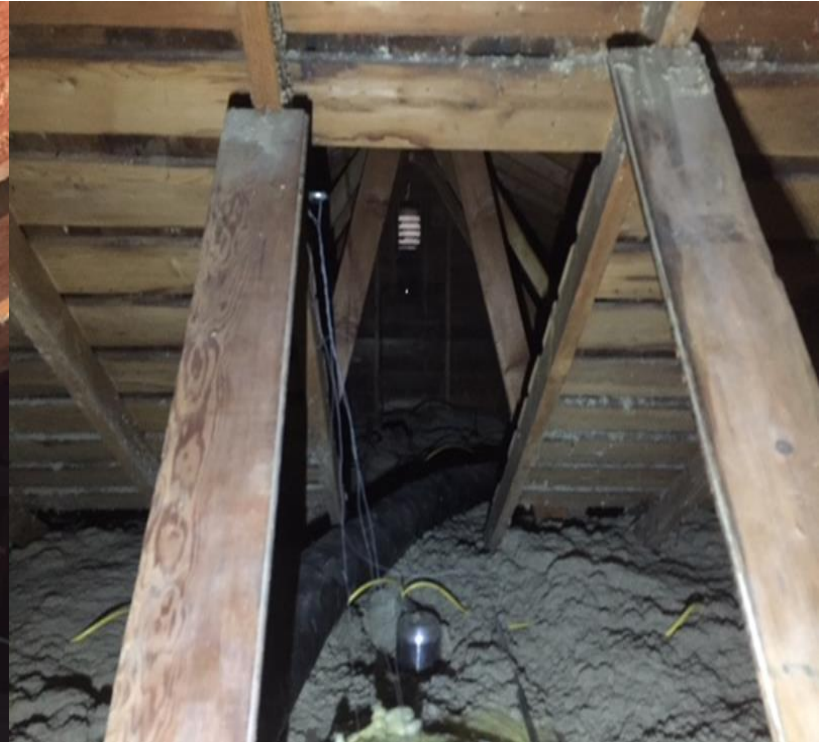
- Insulation
- Current insulation does not meet Wisconsin building code
  - Poor insulation in the ceiling drives higher energy bills year-round.
  - Water damage and missing insulation
  - Doors and windows are not energy efficient

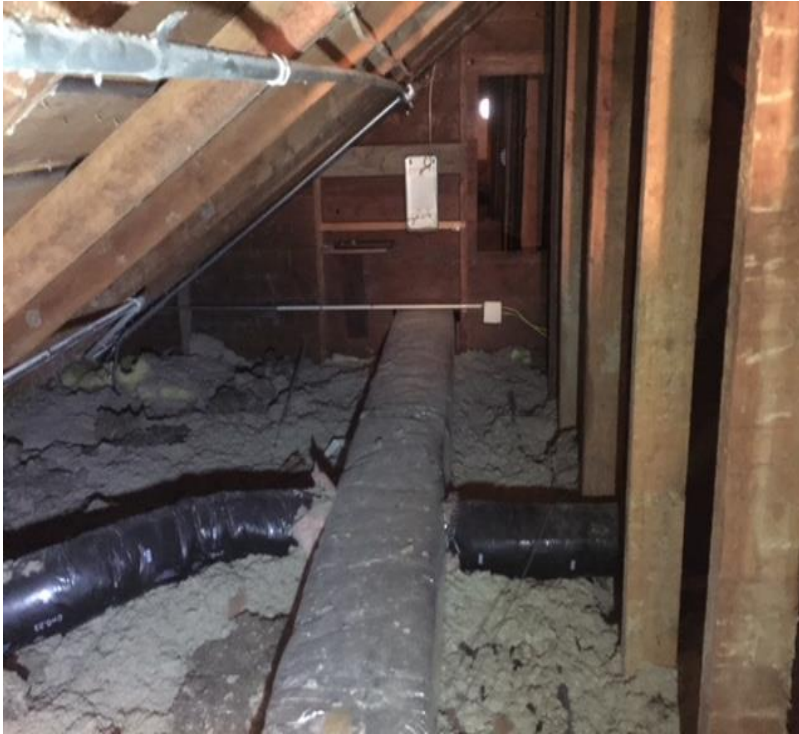
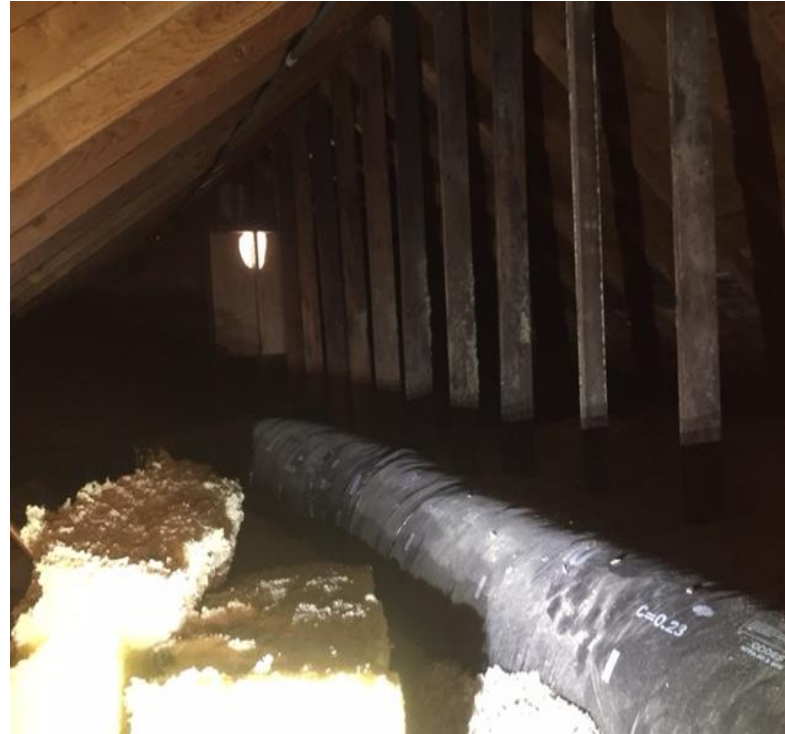
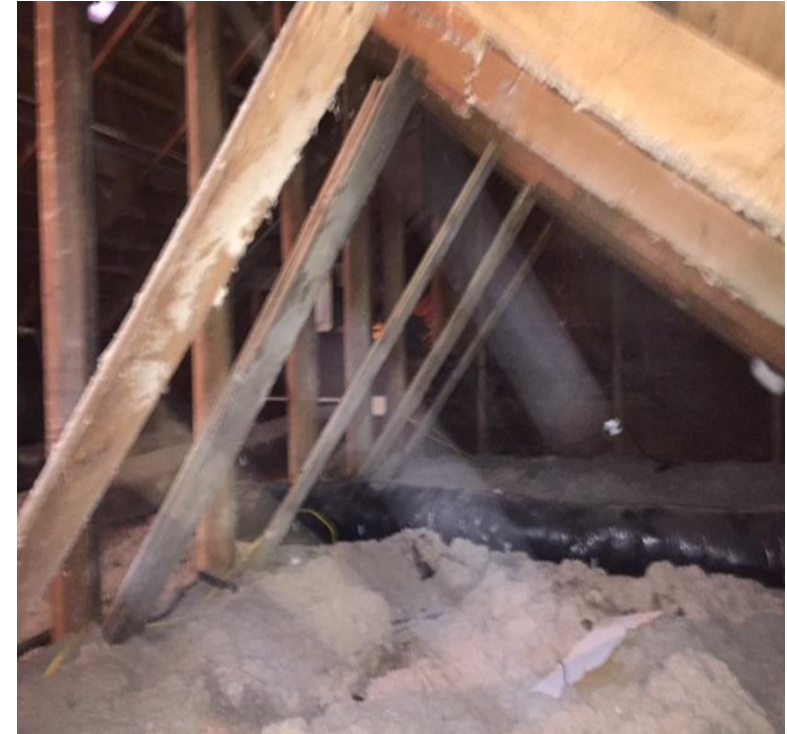
- Water Damage
  - There is evidence of water damage

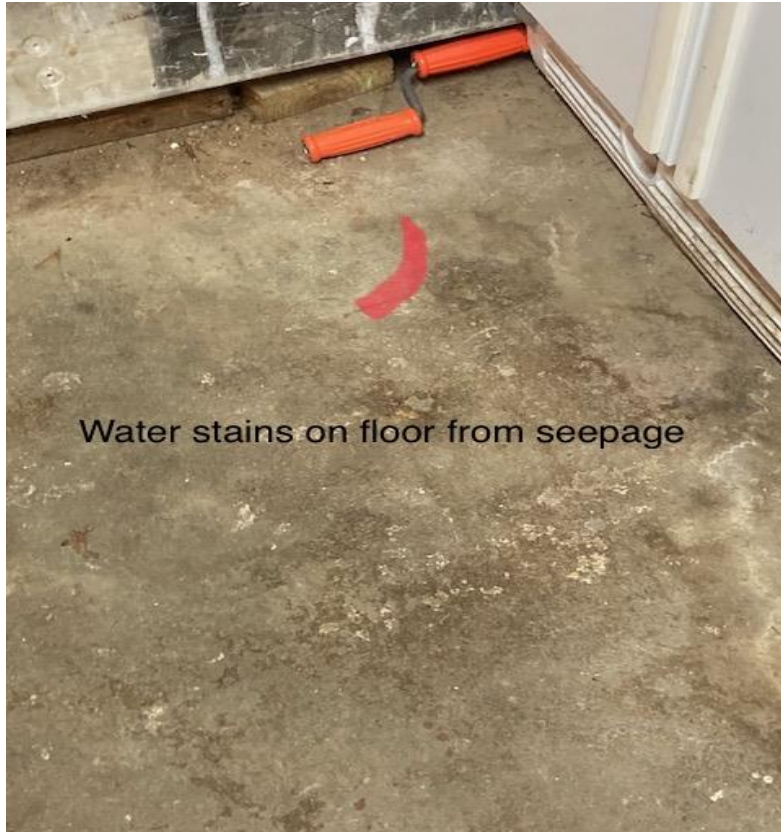
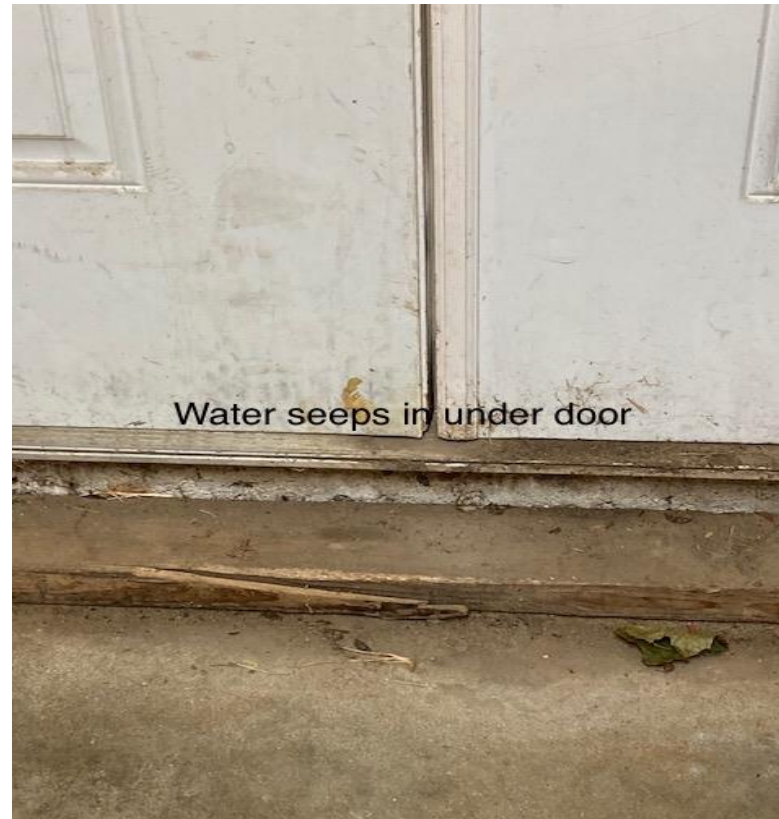
- Mold
  - We had the Hall inspected by a mold mitigation expert
  - Mold was also found in one of the bathrooms

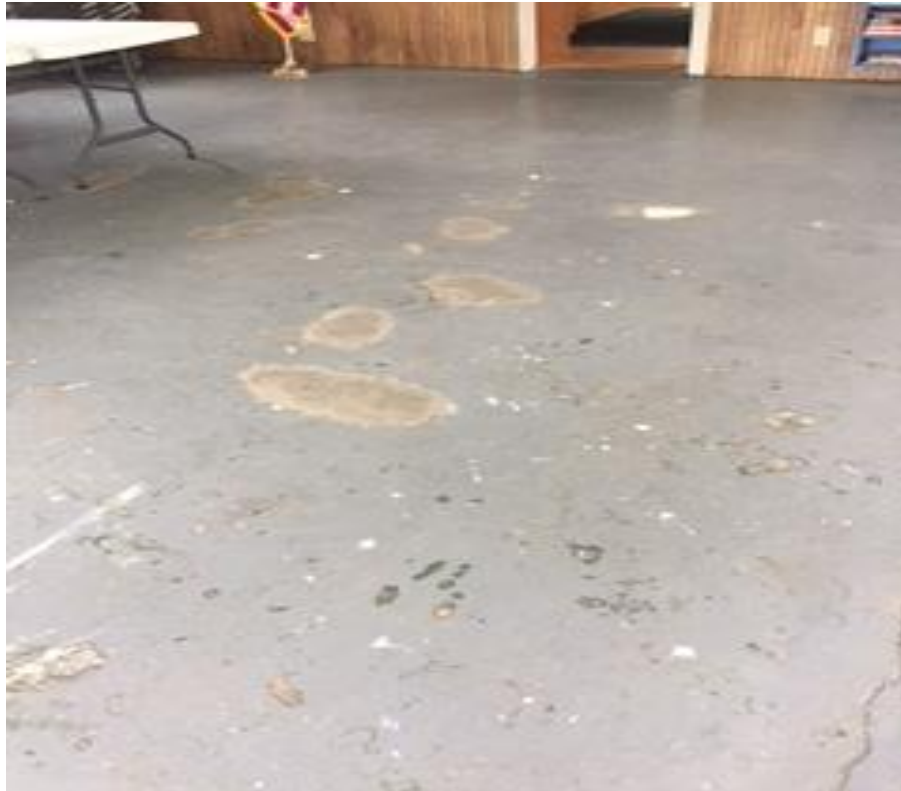
- Floor
  - High moisture content prevents repair
  - Large chunks continue to break out, causing potential trip hazard
  - The floor will need to be replaced

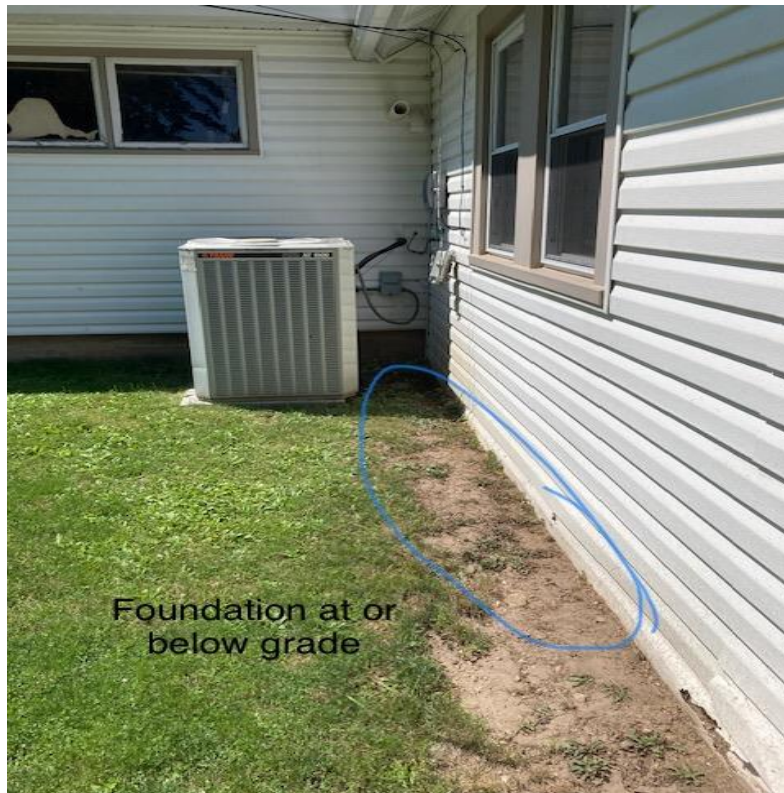
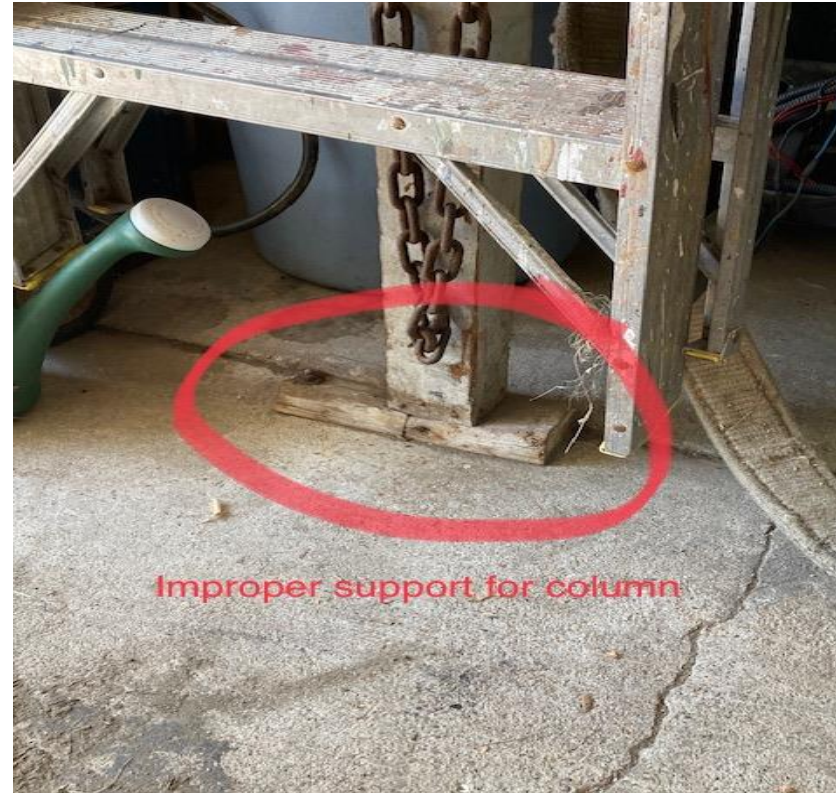
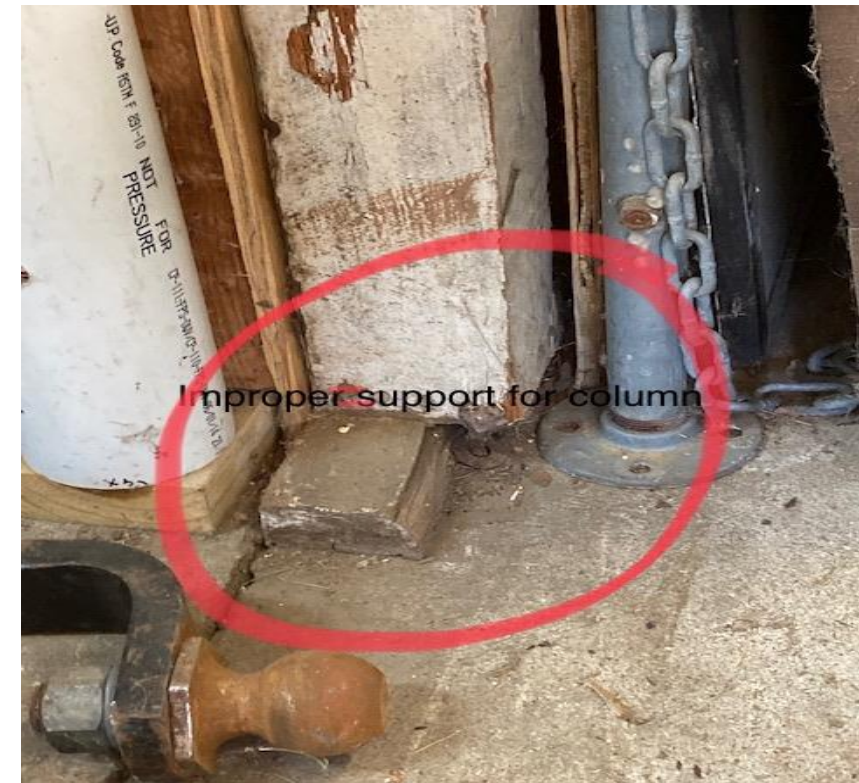
- Structural
  - Issues with the current foundation
  - Structural supports are not to code

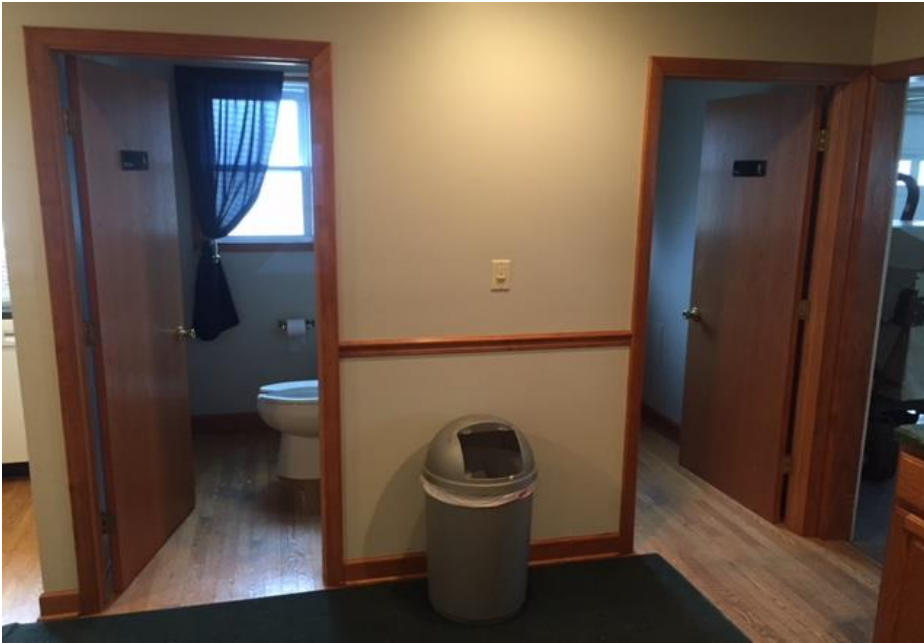
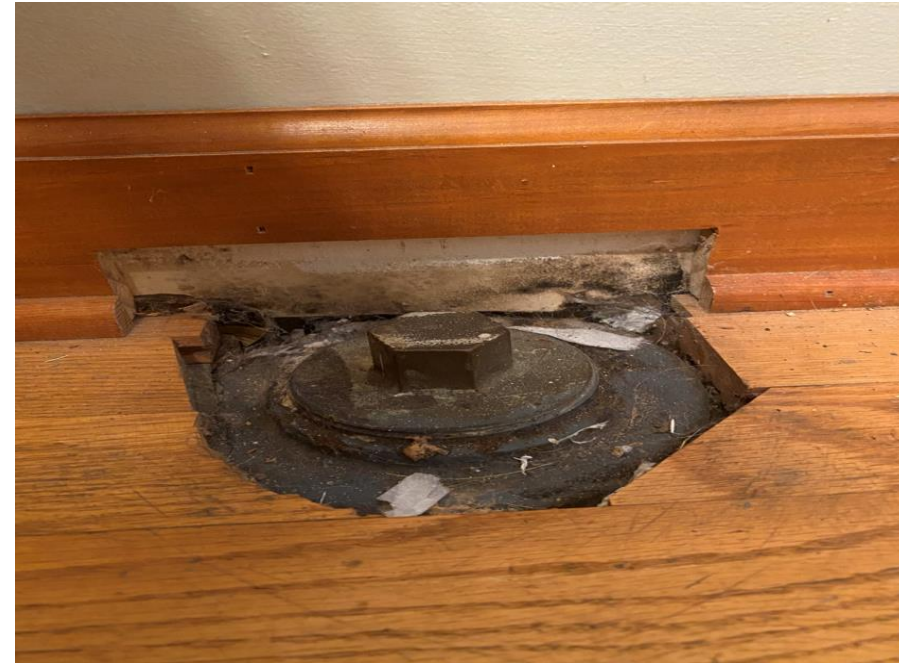
- Bathrooms
  - ADA compliance (~29" opening at present versus 36" requirement)
  - Health concerns with location to food preparation in Kitchen
  - Improved access for members / guests
  - Mold starting in one of the bathrooms

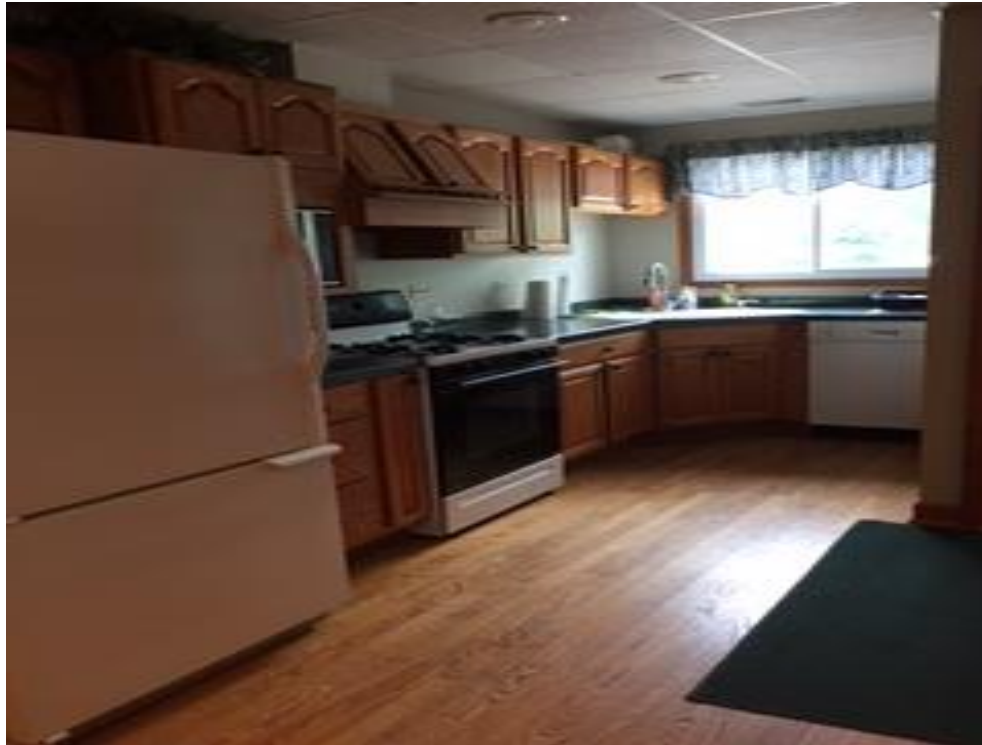
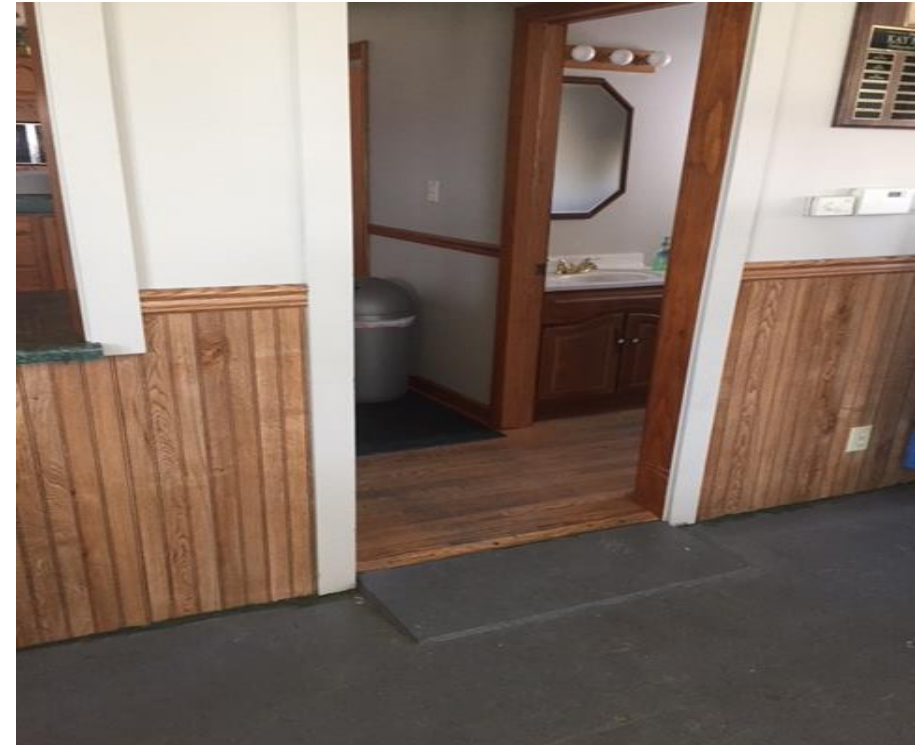
- Kitchen
  - Worn surfaces, cabinetry, and appliances
  - Difficult to keep systems operating and leak free, potential of mold.
  - Floors need repair or replacement with a surface designed for high traffic and proper cleaning.

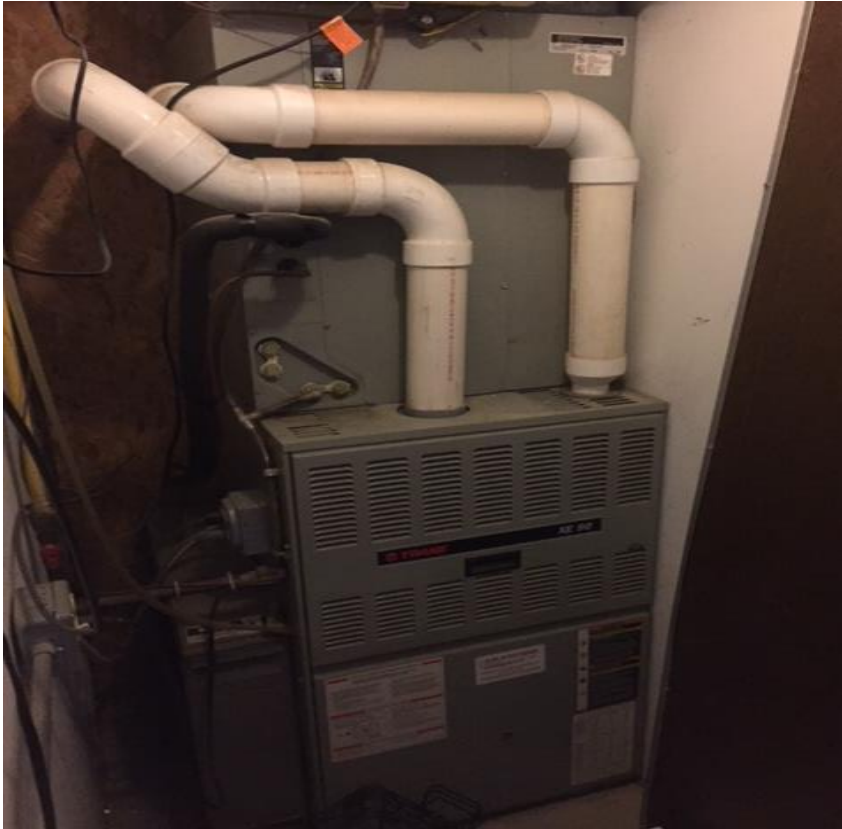
- HVAC
  - The furnace was replaced in May of 2020 (\$2,100)
  - The AC does not work

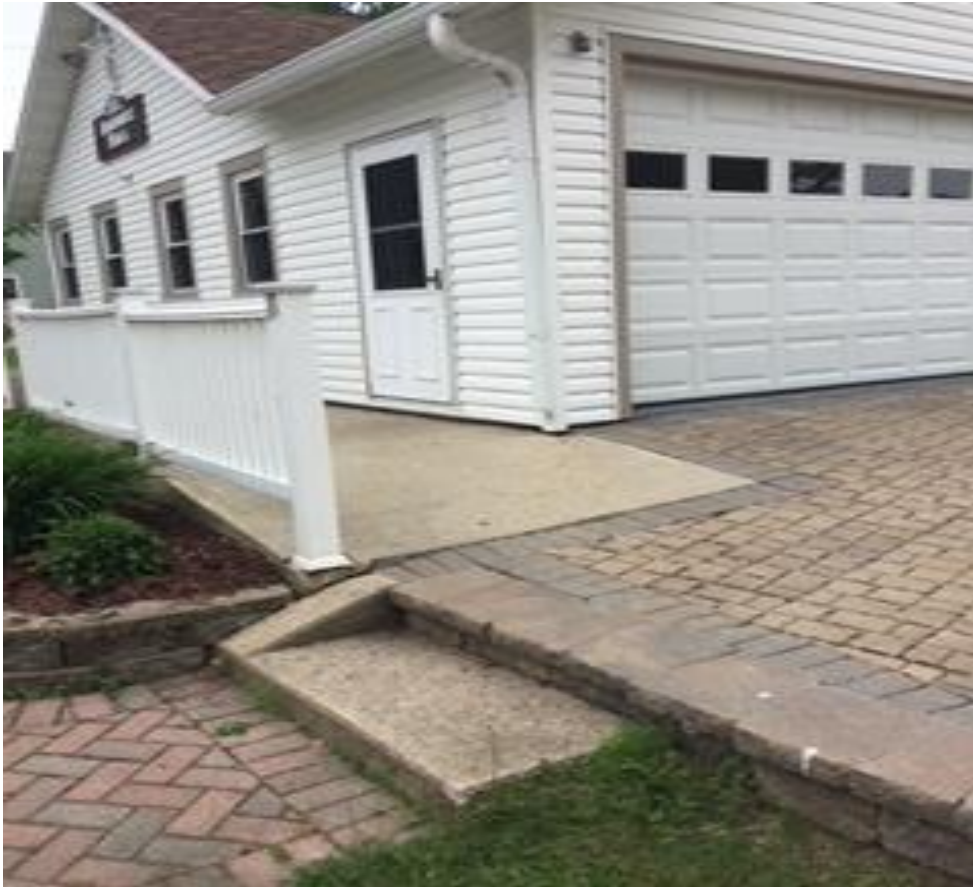
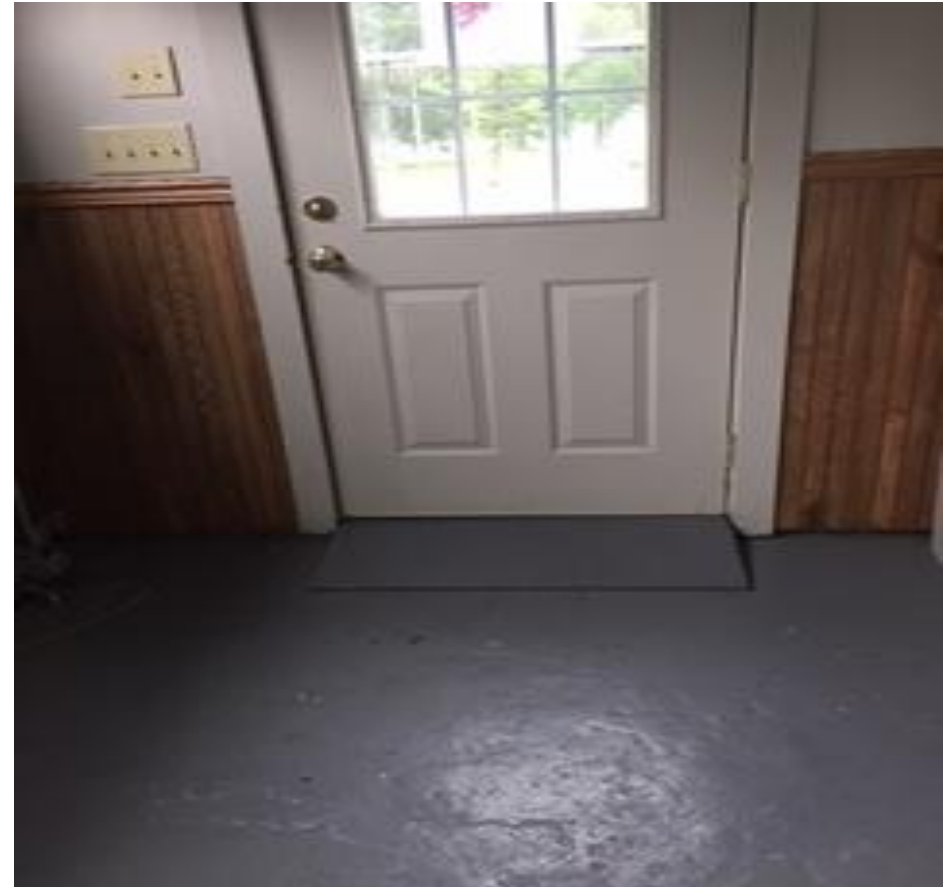
- Entrances
  - Not ADA compliant
  - Sidewalk has obstructed access.
